MINISTRY
OF
YOUTH AND SPORTS

PRESS RELEASE

**CLARIFICATION ON STADIA RENOVATION WORKS AT THE
ACCRA, BABA YARA AND ESSIPONG STADIA**

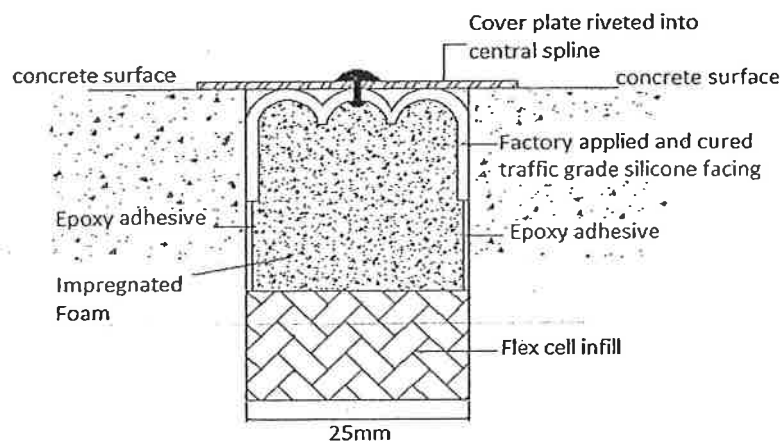
Fig 1; system with cover plate riveted along central spline

The cause was traced to the sealant used in sealing the expansion joints, formed along transitions of the seating tiers and within the stadium arena.

The broken down surface of these joints exposes them, thereby causing rainwater to seep through, penetrating adjoining block work and further staining internal block work partitions of rooms below.

- a) Backpressure of an impregnated foam; b) an epoxy adhesive, and c) an injected silicone sealant band at joint face to foam and silicone bellows interface (*see fig 1*)

For such systems, in order to ensure water tightness, lay down cover plate (aluminium) and screw/rievet into central spline along the transitions of the expansion joints.

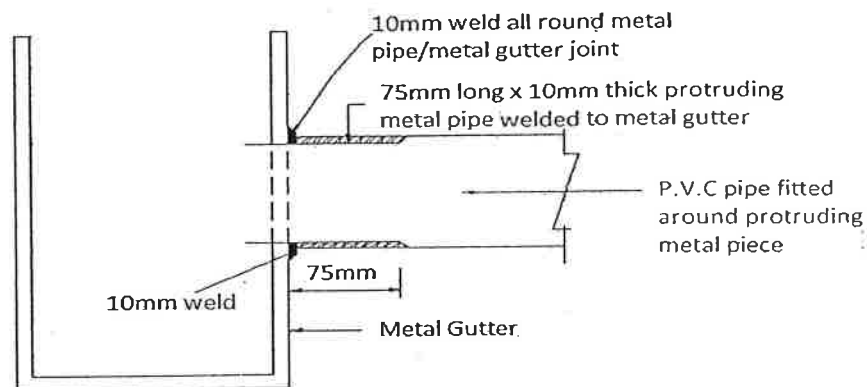
Fig 2; proposed correction to P.V.C pipe/metal joints.

Sealants have been used in sealing such joints (PVC pipe and metal gutter joints). The sealant often weathers with time, thereby allowing water to leak from joints. Observing the roof from the seating arena, one can also identify one of the Perspex glass in roof, to be missing.

The missing glass allows driving rain into one of the sky booth.

The use of sealant at these P.V.C pipe/ metal gutter joints will leak with time. A more lasting solution is to attach a metal pipe (75mm long) by welding to the existing metal

gutters. The pipe should be formed from a 10mm thick metal plate and should be fixed to the metal gutter as shown in the figure below. The P.V.C pipe can then be fitted around the protruding 75mm long metal pipe. NB. The attached metal pipe used must be coated with an antirust paint.
